# Manhole Inspection Summary

Manhole # S47CC\_018MH

Insp Date: **2/4/08 10:17 AM**

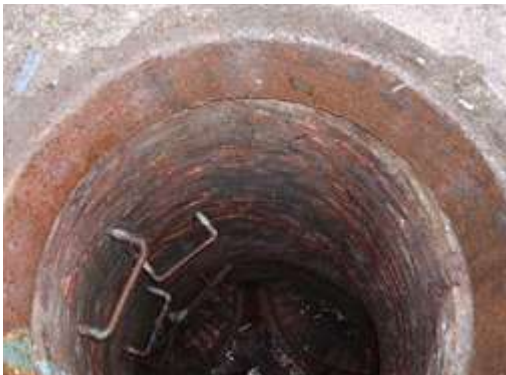
Defect 1

☒ **Leaks**

Infiltration: ☐ None ☐ Joint ☐ Cracks ☐ Mortar ☐ Roots ☒ **Wall**

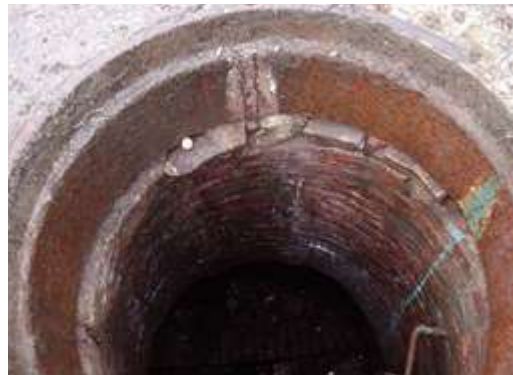
Defect 2

**Steps** Count: **5** Missing: **0** ☒ **Corroded**

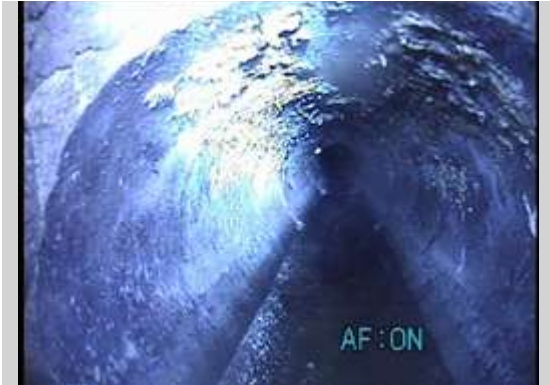
12 O'Clock Outflow

10 in. Circular Gravity Sewer  
Pipe Out @ 12 O'Clock

Pipe Height: **8.4** (in.) Rod and Bar (Angled)  
Pipe Material: **Clay** ☐ Pipe Lined  
Invert Depth: **9.90** (ft.) Flow Characteristics: **None**  
Deposits: ☒ None ☐ Mud ☐ Sludge ☐ Debris ☐ Grease  
Silt Depth: (in.) Deposits Extent:  
Infiltration: **None** Pipe Seal Cond: **Sound**

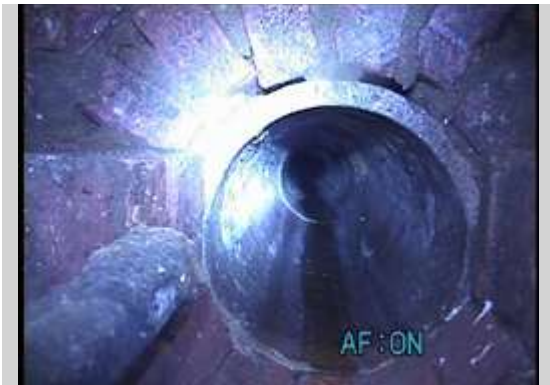
3 O'Clock Inflow

10 in. Circular Gravity Sewer  
Pipe In @ 3 O'Clock

Pipe Height: **8.4** (in.) Rod and Bar (Angled)  
Pipe Material: **Clay** ☐ Pipe Lined  
Invert Depth: **9.85** (ft.) Flow Characteristics: **None**  
Deposits: ☒ None ☐ Mud ☐ Sludge ☐ Debris ☐ Grease  
Silt Depth: (in.) Deposits Extent:  
Infiltration: **None** Pipe Seal Cond: **Sound**

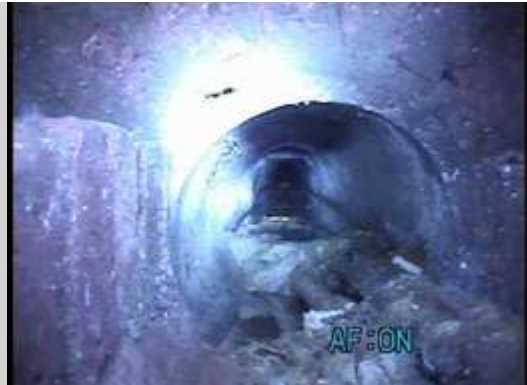
9 O'Clock Inflow

8 in. Circular Gravity Sewer

Pipe In @ 9 O'Clock

Infiltration: **None** Pipe Seal Cond: **Sound**
